NACA RM E57G25

RESEARCH MEMORANDUM

STRUCTURAL DESIGN AND ENGINE EVALUATION OF AN AIR-COOLED TURBINE BLADE COMPOSED OF CORRUGATIONS AND A SEMISTRUT FOR OPERATION AT A TIP SPEED OF 1200 FEET PER SECOND

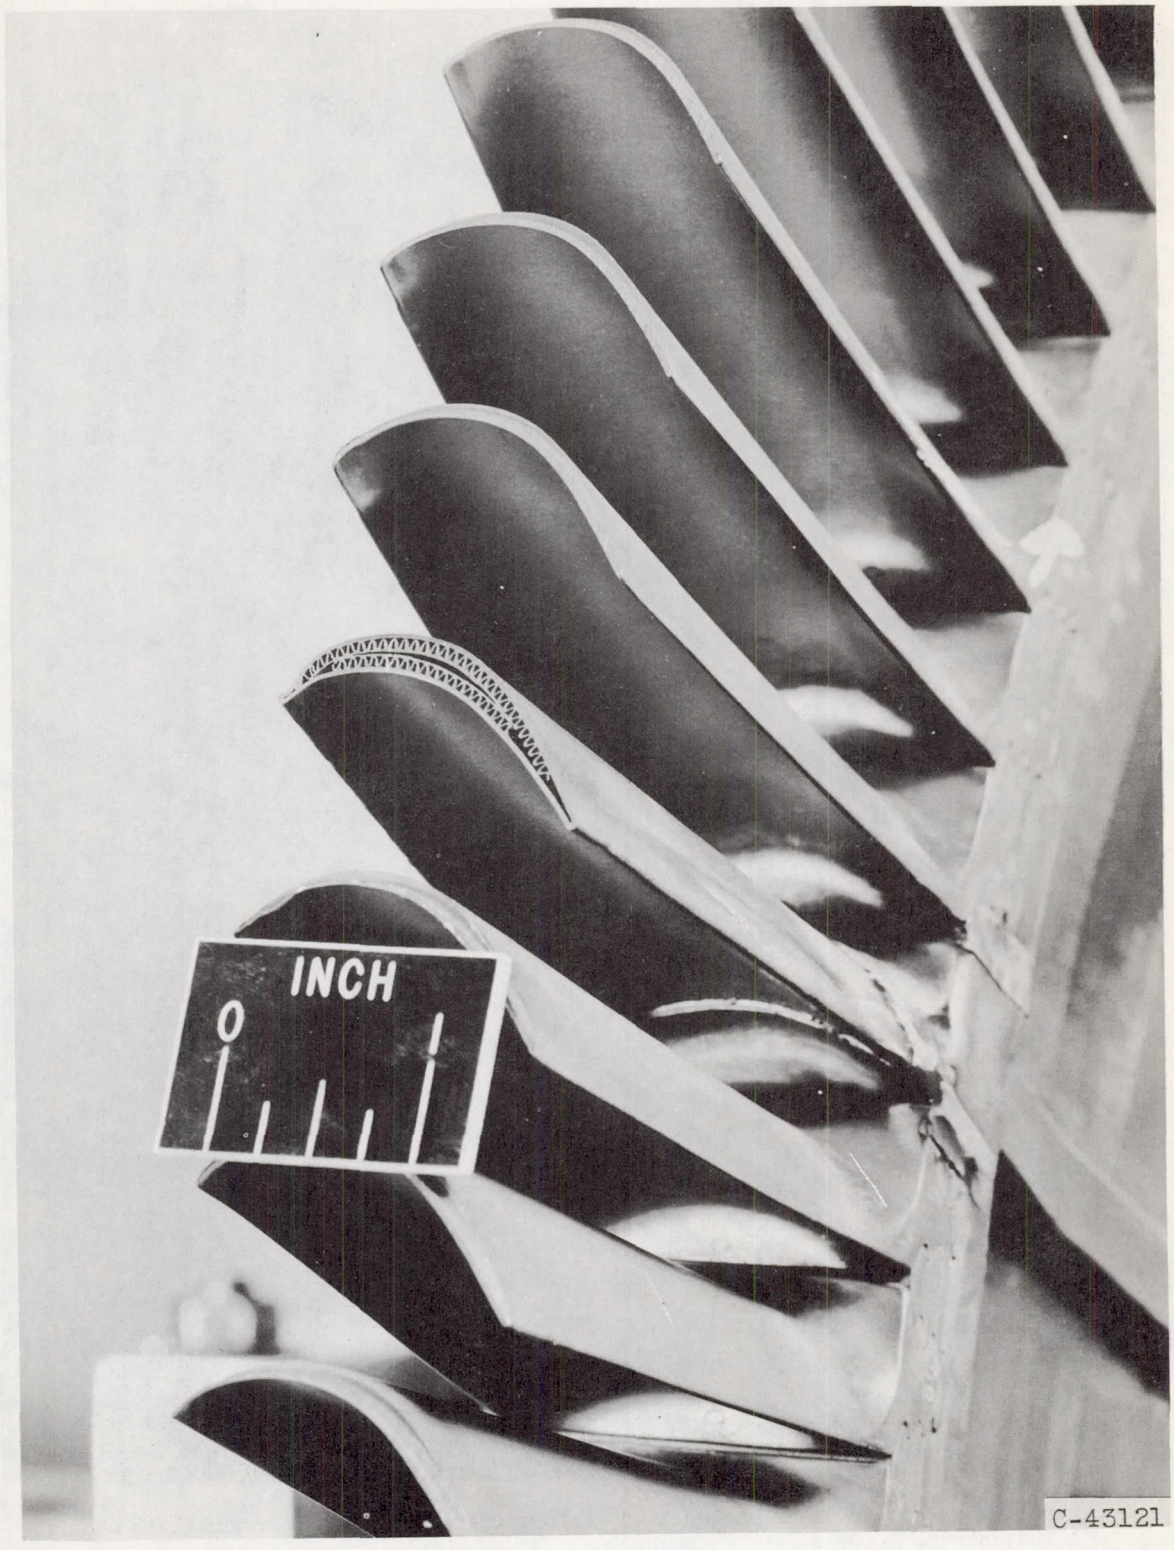
of conditions. They were first subjected to steady-state endurance operation at rated speed and temperature for 100 hours. The first 33 hours were run at a coolant-flow value of 5 percent; the remaining 67 hours were run at a coolant flow of 2 percent. A photograph of one of the blades after the steady-state endurance operation is shown in figure 17. Some indenting of the shell at the leading edge on the suction surface was noted. Again, it is suspected that the foreign particles responsible were hard carbon formed in the combustion chambers. A small crack was again evident in the rim cap of each blade in the trailing-edge region. It is believed that these cracks resulted from stresses induced by the blade repositioning itself in the serration during running. Since the rim cap was welded to the rim of the wheel while stationary, stresses would be imposed when the blade shifted because of the centrifugal forces. This is a minor item associated only with the particular way in which the blade was mounted in this wheel. In a full-scale design this problem would not exist. In all other respects, the two blades were in very good condition at the end of the 100 hours.

Figure 17. - S-816 - L-605 blade after 100 hours of operation with cooling air.

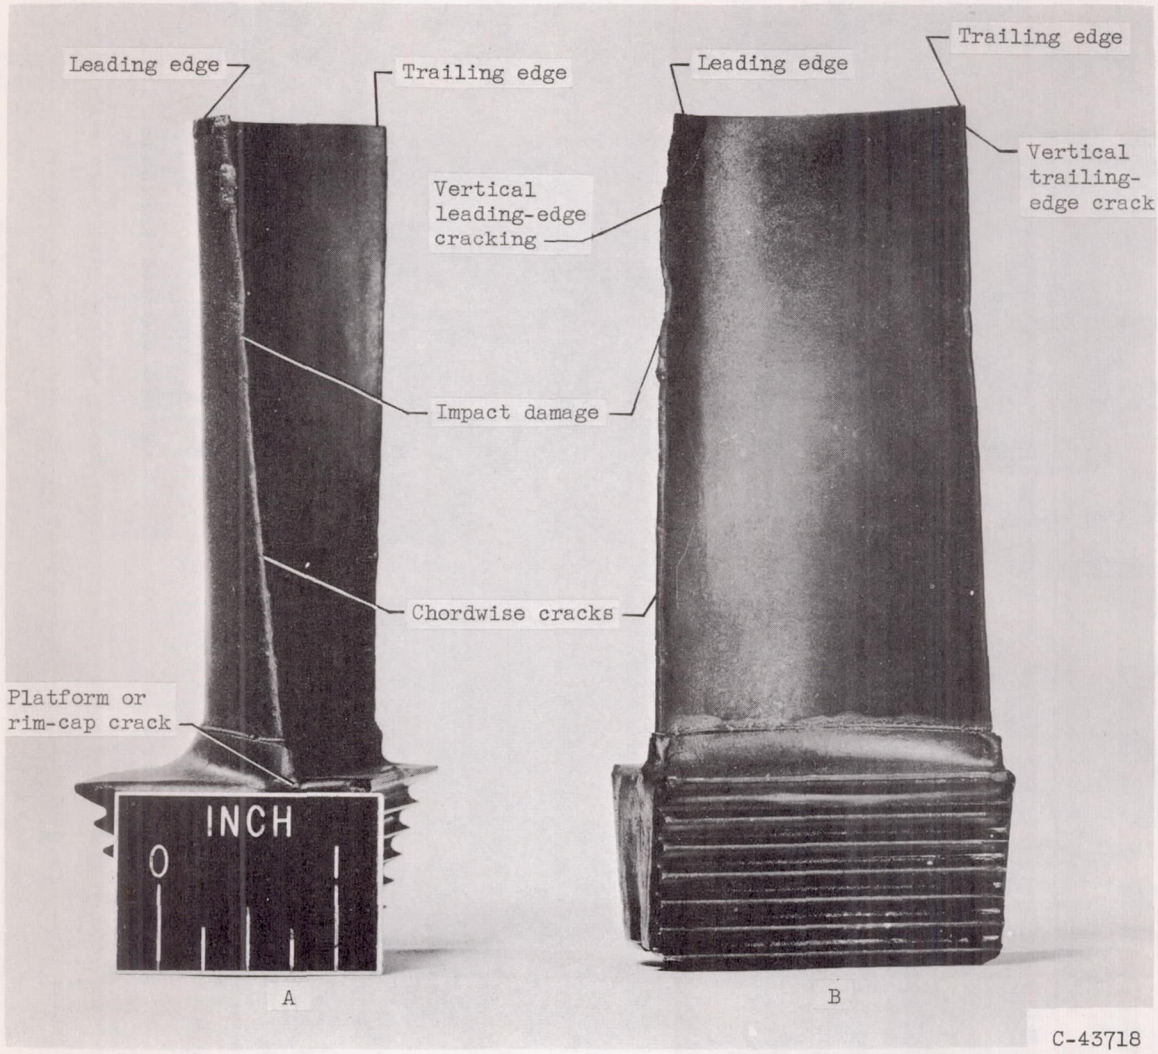
Two blades of this type were operated in a steady-state endurance run at rated speed and tailpipe temperature with 2-percent cooling air. After 55 hours and 37 minutes of rated operation, a cooling air supply tube on the face of the rotor tore loose and terminated the test run. A photograph of the two blades after the engine operation is presented in figure 20. Although the blades were still serviceable, there was evidence of deterioration as shown in the photograph. Essentially two types of damage are evident; one is due to impact and the other is due to weld-cracking. The impact damage is prominent only on the suction surface near the leading edge. Markings in this area indicate that the foreign-particle size varied from small particles which barely nicked the surface to those large enough to indent the shell as much as 0.030 to 0.050 inch. This type of damage was not obtained when the same combination of blade design and shell thickness was operated in a different engine in the same test stand (ref. 1). A possible explanation may be the formation of hard carbon particles in the combustion chambers of the engine used herein.

The second type of damage noted was cracking in the welds of the leading and trailing edges. In the trailing edges of both blades, cracks started in the weld at the tip and progressed downward from 1/2 to 3/4 inch. On the leading edge of both blades, a crack started in the weld $2\frac{1}{4}$ inches from the tip and progressed in the chordwise direction approximately $\frac{1}{4}$ inch on the pressure surface. On the leading edge of blade B (fig. 20), a crack started in the weld at the tip and progressed downward about 1 inch. A small portion of the shell at the tip was subsequently lost as can be noted in figure 20. Also, small cracks in the rim cap are evident.

Figure 20. - A-286 - X-40 blades after 55 hours of operation at turbine-inlet gas temperature of 1650° F.

Although the struts or the main load-carrying member of these blades were probably sound and the shell cracks could have been repaired, no further running was done with these blades.

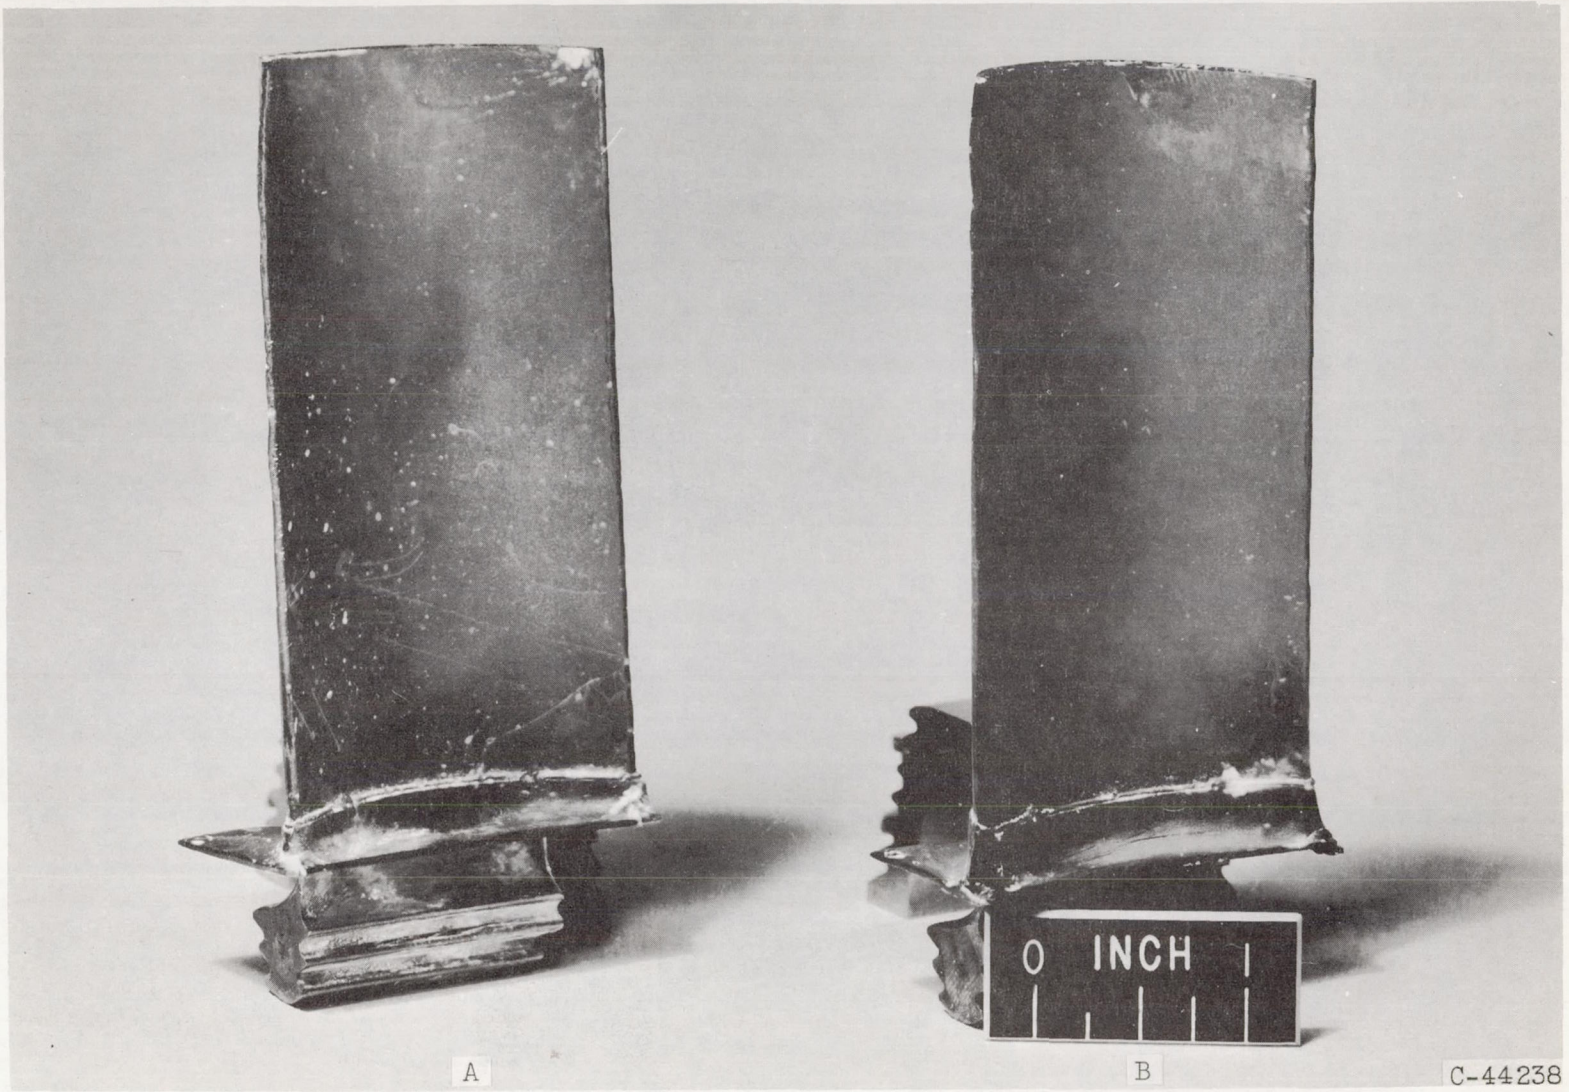
Cyclic endurance operation. - After the 100 hours of steady-state endurance operation, the same two blades (without reworking of any kind) were subjected to a cyclic operation to obtain an indication of their resistance to thermal shock. The cycle consisted basically of starting and stopping the engine in the normal manner while maintaining, at all times, a coolant flow of 2 percent (based on the engine mass flow per blade at rated conditions). The engine was allowed to remain at rest for 20 minutes before the next start to ensure the return of the blade temperature to room value. Inspection at regular intervals consisted of visual and penetrant-oil surveys. In addition, the engine was operated briefly at rated conditions at regular intervals as a further check on the structural integrity. At the end of 300 cycles of operation the blades were still in good condition as shown in figure 21. This photograph is a combined natural-light and black-light double exposure to show the results of the final penetrant-oil inspection. Very small indications are noted along the leading edge of blade A. It is doubtful that these are actual cracks; they are probably false indications caused by irregularities in the surface produced by foreign-particle impact. The white spot at the tip of blade A near the trailing edge is definitely a false indication.

Leading-edge cracking of solid blades induced by thermal cycling has been a problem in the engine in which the cooled blades were operated. Many standard solid blades have shown evidence of cracking in the same time of operation to which the cooled blades were subjected (ref. 2). The final condition of the cooled blades after both the steady-state and cyclic operations indicates a resistance to thermal shock which is at least comparable to, if not better than, the standard solid blades.

Figure 21. - S-816 - L-605 blades after 100 hours of steady-state operation with cooling air and 300 stop-start cycles.
